Notice of Council Assessment Panel Meeting

COUNCIL ASSESSMENT PANEL MEETING 19 SEPTEMBER 2023

- 4.1 CAP. 23018419** - Significant Council tree removal (Eucalyptus Camaldulensis - River Red Gum) on the Council verge in front of 4 Beryl Court, Modbury **3**

REPORT NO: CAP.23018419

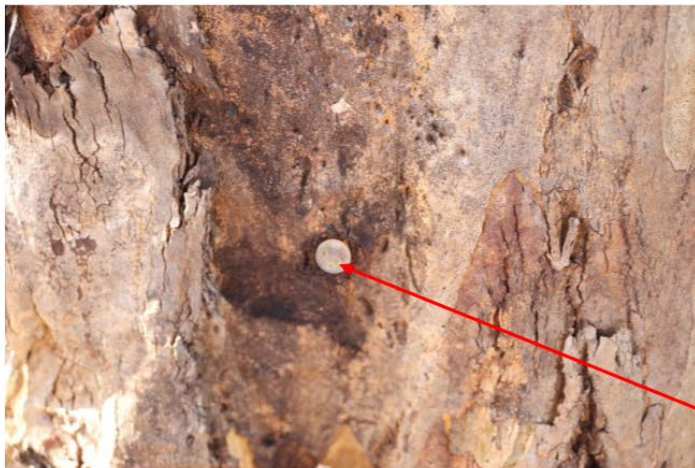
Trunk integrity: The trunk is in a healthy condition sound testing indicated no decay or basal rot but there was plugs around the lower trunk indicating possible termite treatment. Integrity would be good.

chemicals

Tree plug for

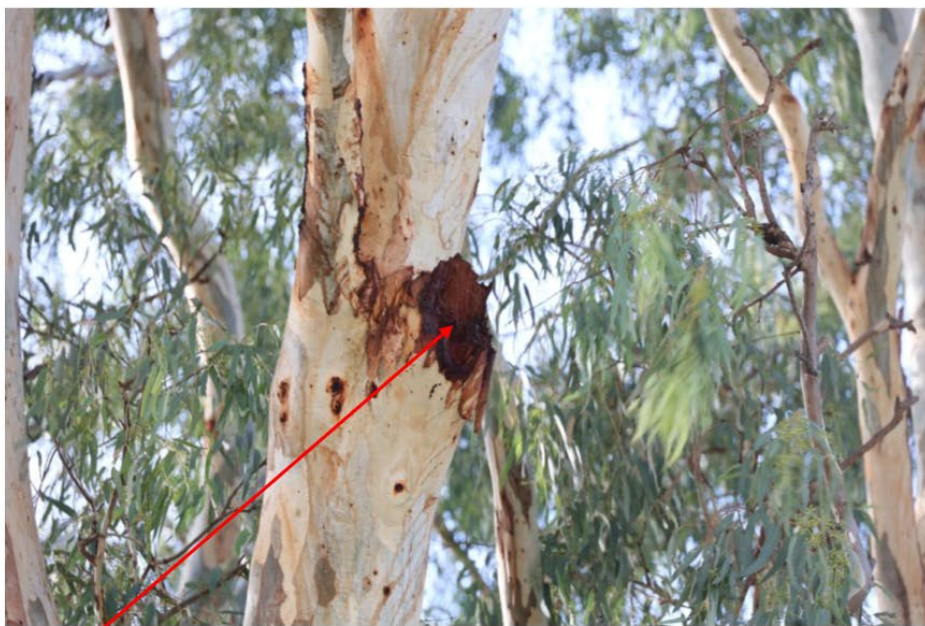
Branch integrity: The majority of branches are in a good condition but one branch has fallen and there has been recent trimming. There is minor included bark unions that should be monitored for their structural integrity. Integrity would be average to good.

Branch failure

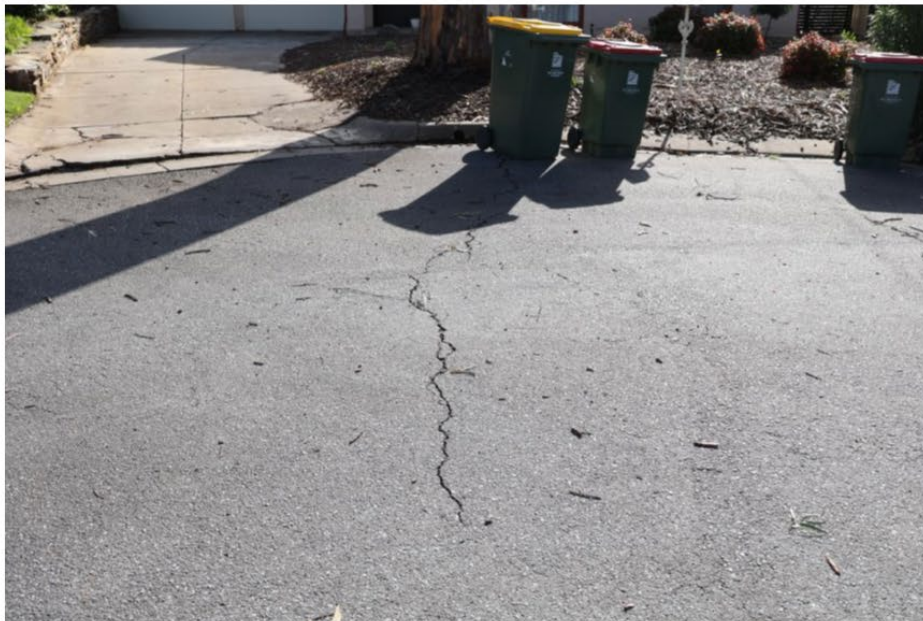
Driveway, kerbing and roadway are being damaged by the tree with its aggressive roots.

Driveway, kerb and roadway cracking

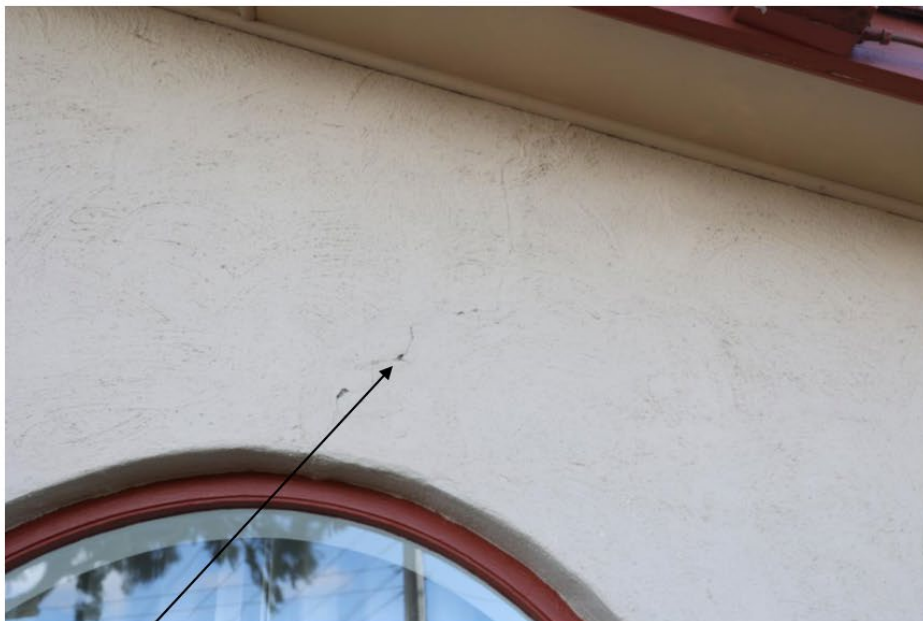
There is cracking above the front windows at number 4 Beryl Court but I could not identify if the tree was the problem (may require a structural engineer to verify).

Cracking at number 4

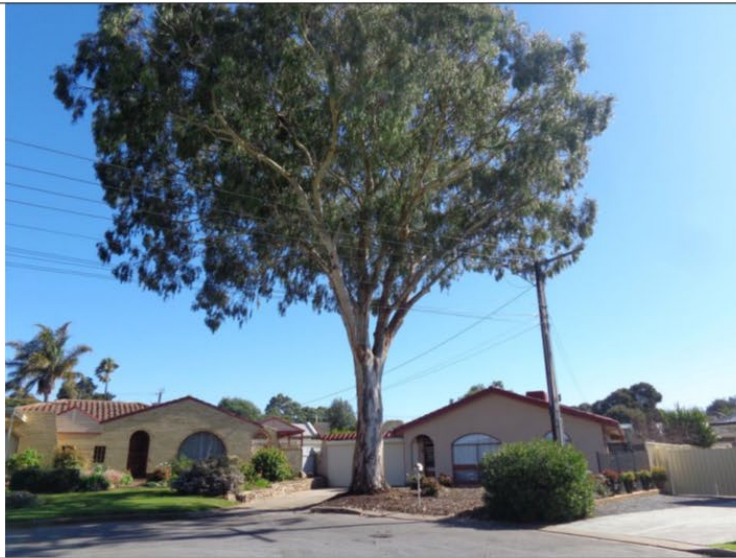
PHOTO 1 – View of River Red Gum on council verge adjacent 4 Beryl Court, Modbury. The tree is approximately 17m high with a 20m diameter canopy and has a circumference of 3020mm measured 1000mm from the base. The zone of root influence would likely impact the dwellings at 3, 4, and 5 Beryl Court.

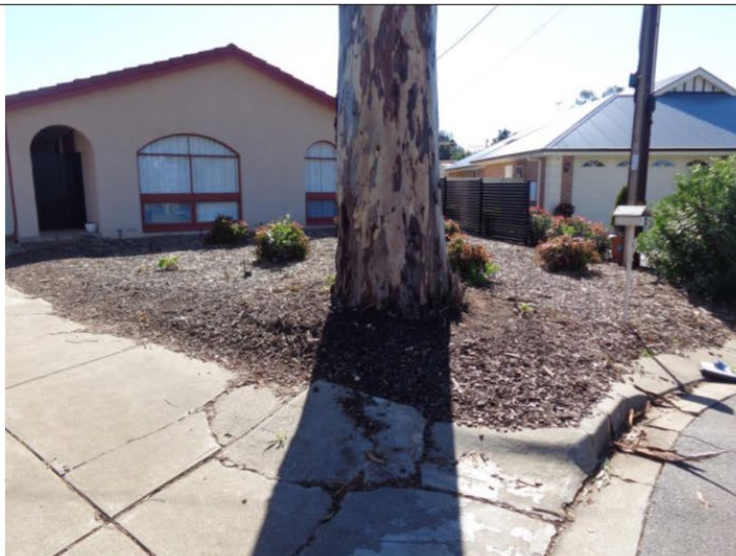
PHOTO 2 – Closer view of tree base. Notice the cracking to the driveway at No.4.

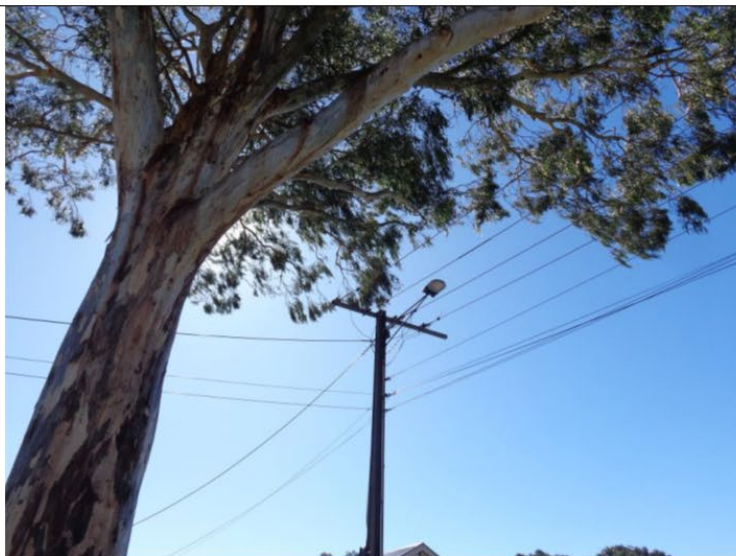
Conceptio Engineers report also identifies that the tree poses a potential risk to power supply and a potential fire hazard in relation to the location of the tree relative to powerlines.

PHOTO 3 – View of canopy showing the utility pole in the background. Any potential falling branches are not going to make any significant contact with any of the dwellings; however, the power lines are potentially at risk of falling branches.

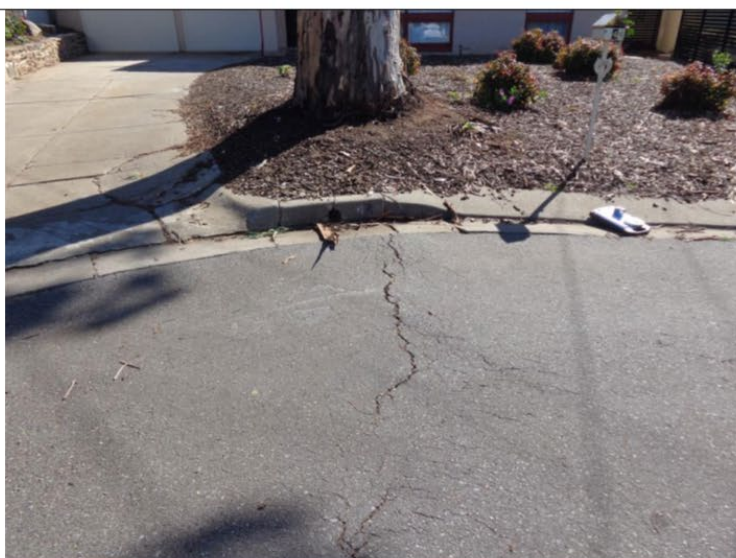
PHOTO 4 – There is localised heave to the gutter and roadway adjacent to No.4 which appears to be as a direct result of the tree and has not been repeated elsewhere on the cul-de-sac – refer to photograph 9. The cracking in the bitumen propagates from the gutterline out towards the water/sewer service points (Gatic covers) in the roadway – refer to photographs 6, 7, and 8.

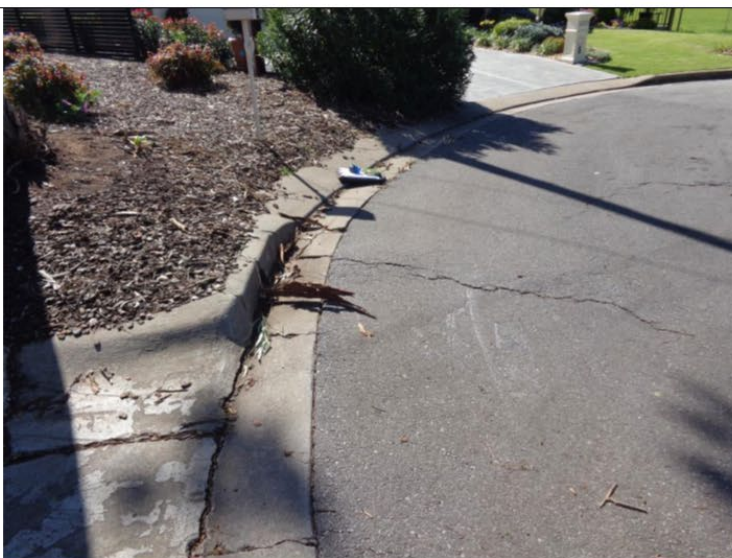
PHOTO 5 – A sideview of the propagating crack shown in photograph 4. There is heave in the road and gutter at this location.

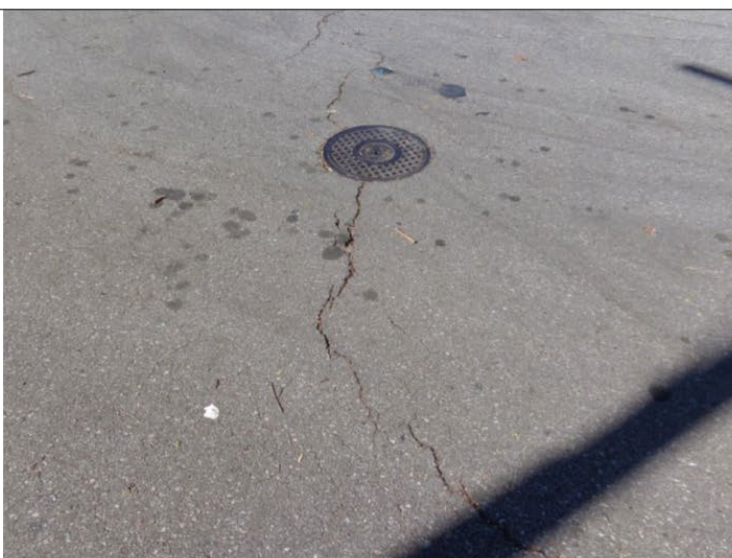
PHOTO 6 – The cracking in the bitumen extends to the SA Water sewer inspection point. There has been extensive callouts for SA Water (particularly over the last 3 years) for No. 3, 4, and 5 Beryl Court, due to tree roots blocking and clogging drains. It has also been noted by SA Water that broken pipework was discovered; however, it is unclear whether this has been repaired.

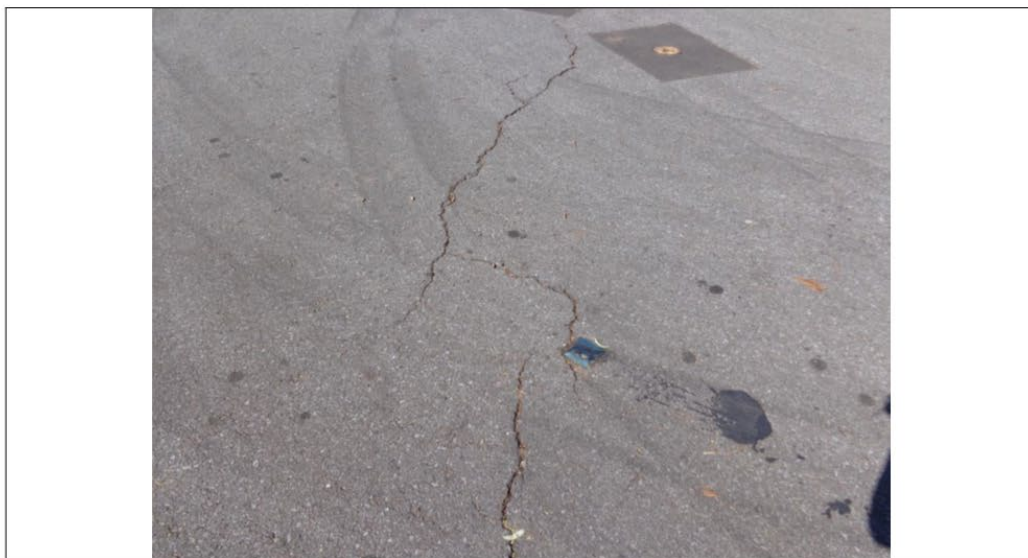
PHOTO 7 – Further cracking to the road propagating from the direction of the tree towards the road service points. The remaining road surface is uncracked. It was indicated that both the connection points and the main pipework for the sewer had been impacted by tree roots at some stage. The cracking to the road could be a direct result of roots that are relatively close to the surface.

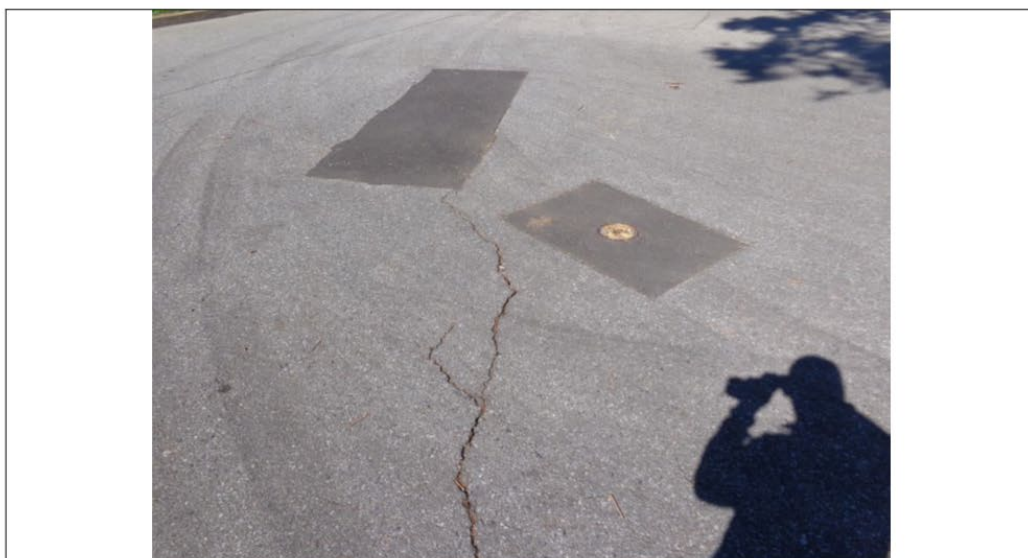
PHOTO 8 – The patches to the road indicate access to underground services for some form of maintenance or repair – details were not stated on the SA Water maintenance schedule.

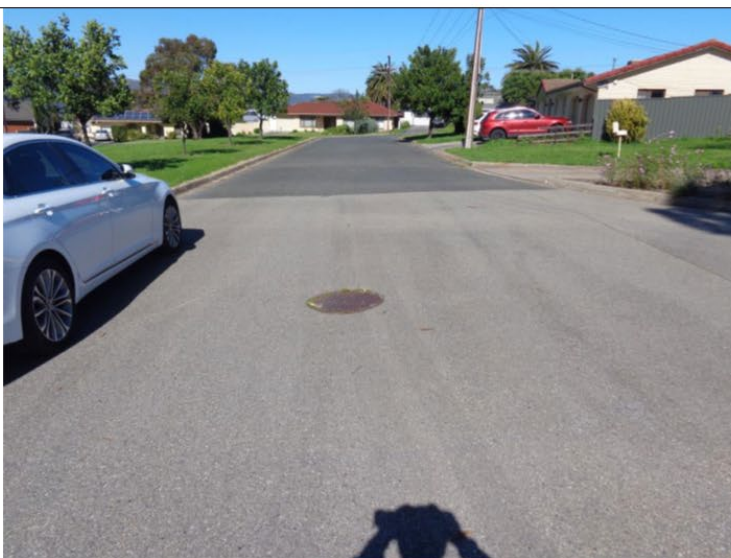
PHOTO 9 – Another SA Water inspection point further down Beryl Court which appears in good condition with no localised cracking evident. This inspection point is positioned away from the zone of tree root influence and there are no significant trees located within close proximity. Part of Beryl Court has had the bitumen redone as per the colour contrast.

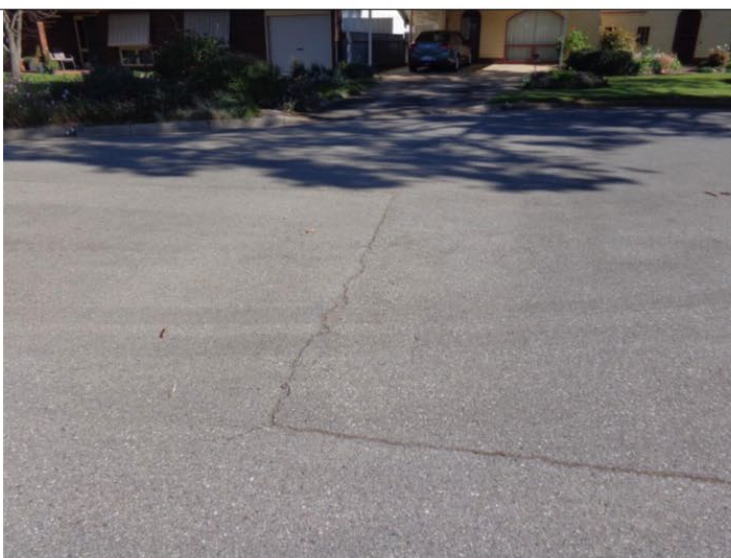
PHOTO 10 – A large section of the bitumen towards the end of Beryl Court appears to have been cut out and replaced – time frame and reason not known. Generally, the bitumen covering appears to have functioned satisfactorily without any cracking or settling etc. The gutters to the cul-de-sac appear to be the original gutters.

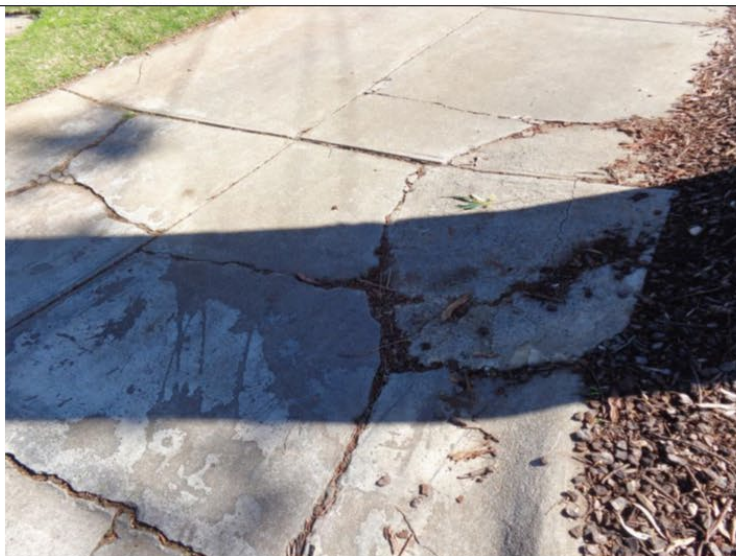
PHOTO 11 – The concrete driveway to No.4 has been severely broken immediately adjacent to the tree. As you move further away from the tree the condition of the concrete driveway improves. Refer also to photograph 2.

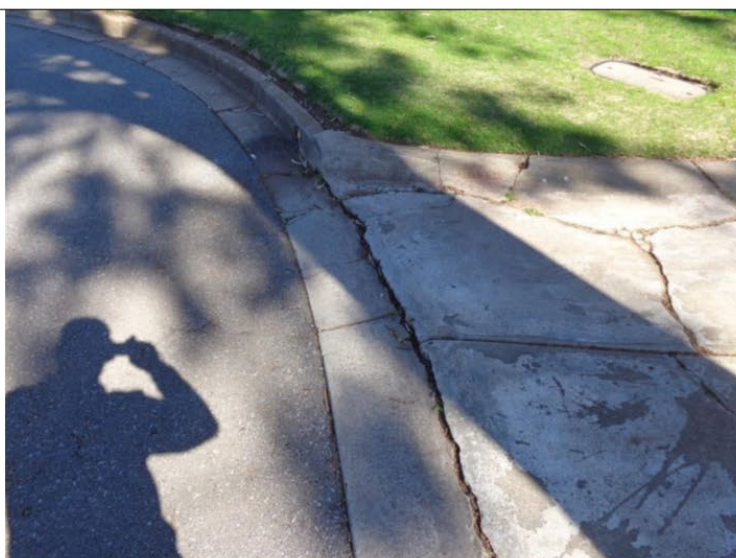
PHOTO 12 – Crossover at No.4 Beryl Court. The last panel of the driveway doesn't even discharge rainfall runoff adequately to the road due to a backfall.

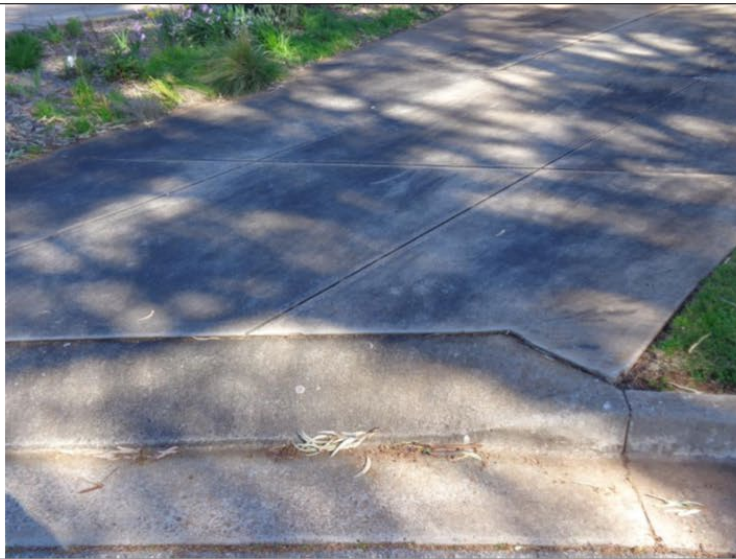
PHOTO 13 – The driveway to No.3 Beryl Court is in good condition generally. It is not known whether this is the original driveway; however, it is certainly an old driveway, that is, not recently laid. Moving further away from the tree has had a noticeable impact on the state of the driveway.

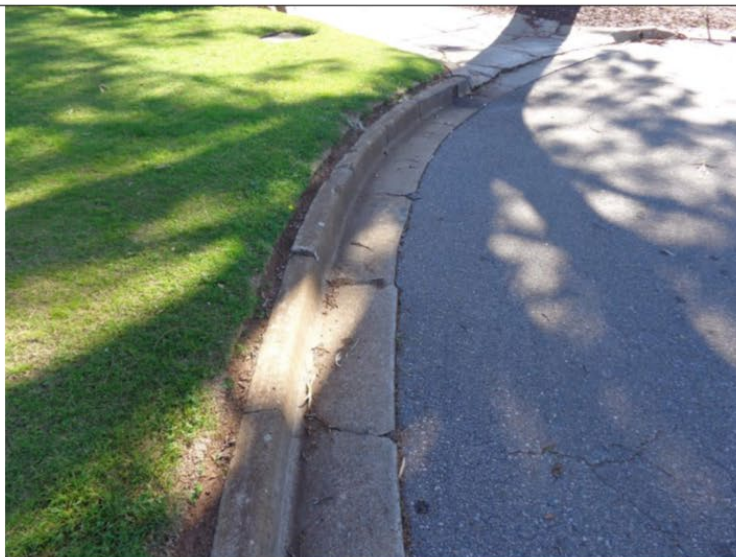
PHOTO 14 – View of the kerbing between No.3 and No.4. Although some cracking exists in the gutter (not uncommon) there hasn't been much by way of vertical displacement of the gutter.

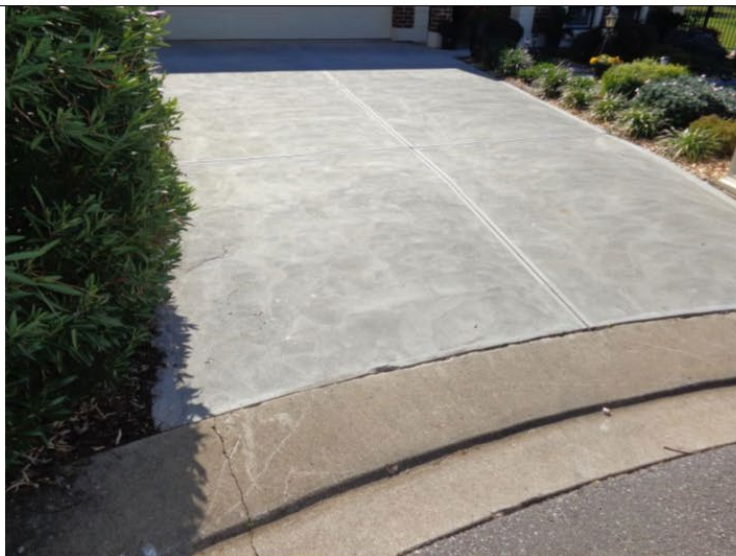
PHOTO 15 – The driveway to No.5 is quite new in comparison and has not suffered any noticeable movement. The crossover is in reasonably good condition also with only some minor cracks.

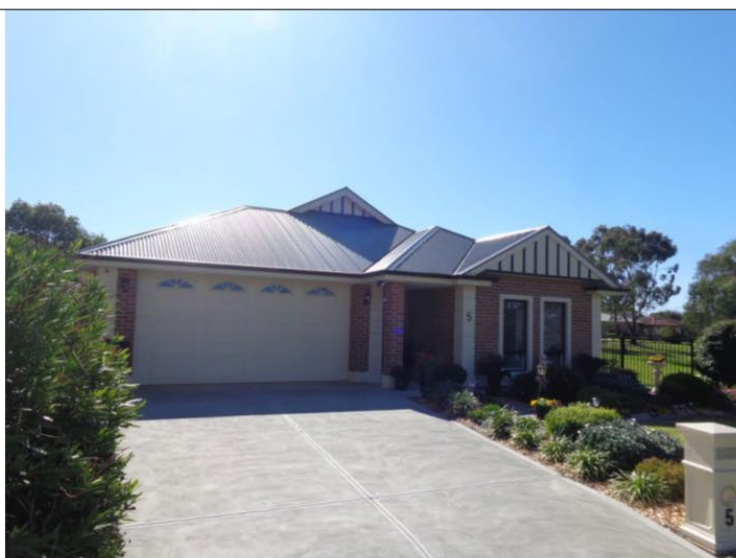
PHOTO 16 – A view of No.5 dwelling which is substantially newer than No.3 and No.4. It is estimated that the dwelling is somewhere around 10 years old. If this is the case the raft footing would have been designed to AS2870-2011 Residential Footings which takes into consideration the influence of large trees on soil movement with regards to the raft slab footing design.

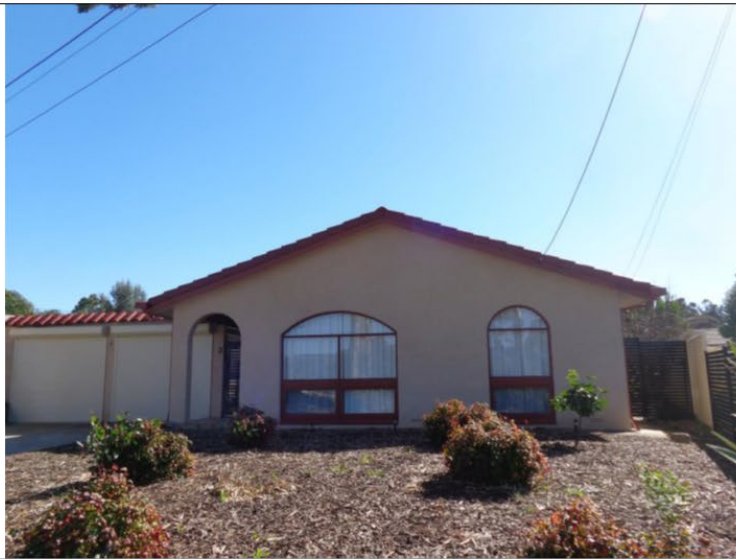
PHOTO 17 – The dwelling at No.4 was constructed in 1975. Although not inspected internally it is likely to be solid masonry construction, with strip footings and timber floors and a concrete tiled roof. Externally the dwelling demonstrates minimal movement given its age, and the roof lines and gutter lines do not indicate any building undulations.

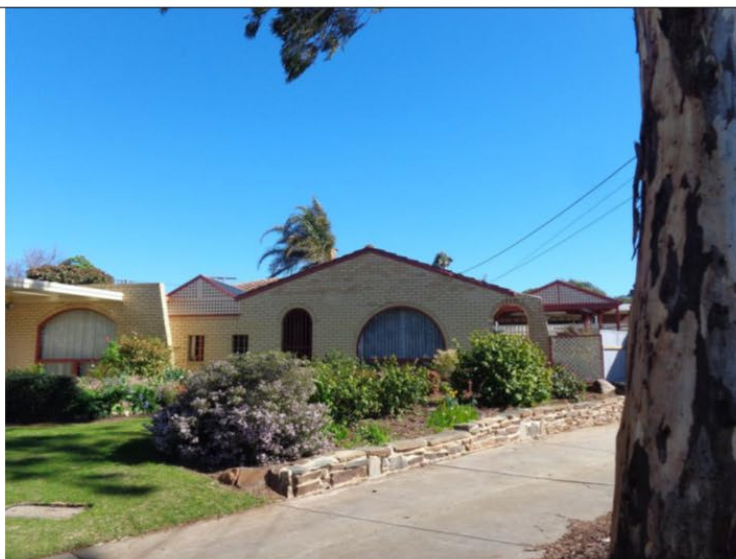
PHOTO 18 – The dwelling at No.3 was likely built around the mid 1970's and reflects a similar construction approach to No.4 including the use of arches. Arches tend to be susceptible to cracking at the apex if the building undergoes reasonable movement – there was no distinct cracking noted. The roof lines and gutter lines appeared in good condition with no building undulations noted.
