Notice of Council Assessment Panel Meeting

COUNCIL ASSESSMENT PANEL MEETING 19 SEPTEMBER 2023

- 4.1 CAP. 23018419** - Significant Council tree removal (Eucalyptus Camaldulensis - River Red Gum) on the Council verge in front of 4 Beryl Court, Modbury **3**

REPORT NO: CAP.23018419

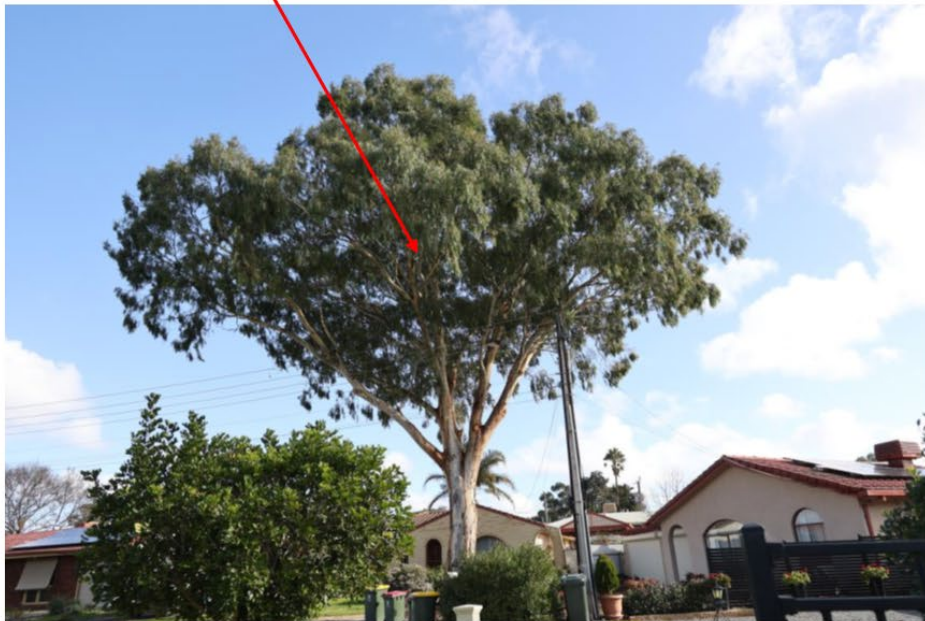
Tree species: *Eucalyptus camaldulensis* (River Red Gum)

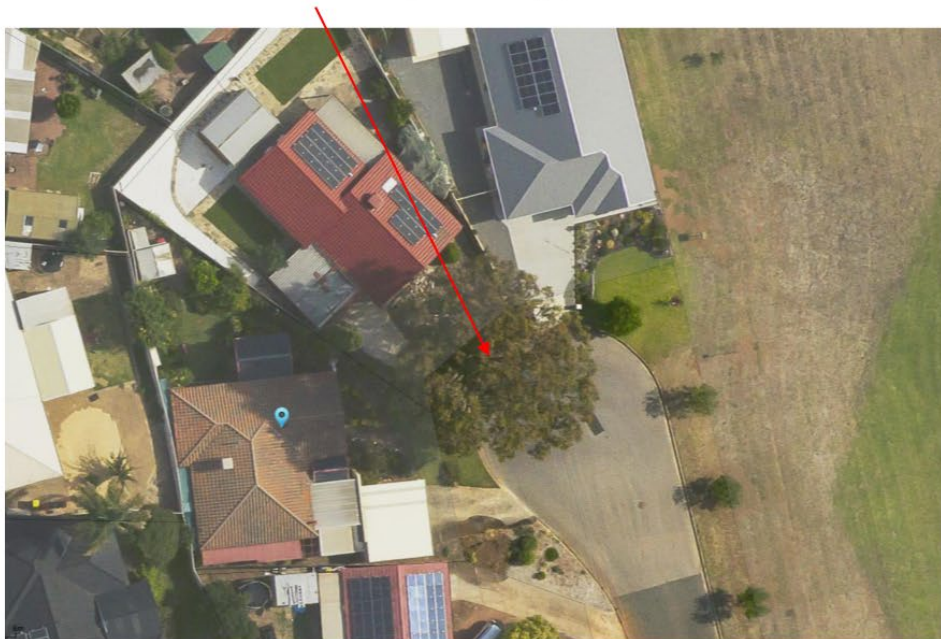
Location of tree: Front of allotment (council verge).

Current condition: This Eucalypt is in a healthy condition with recent trimming and healthy foliage.

Circumference of tree (1m above ground level): 3.01m (Significant tree)
